# ALERT

May 1996

## Preventing Silicosis and Deaths in Construction Workers

DHHS (NIOSH) Publication No. 96-112

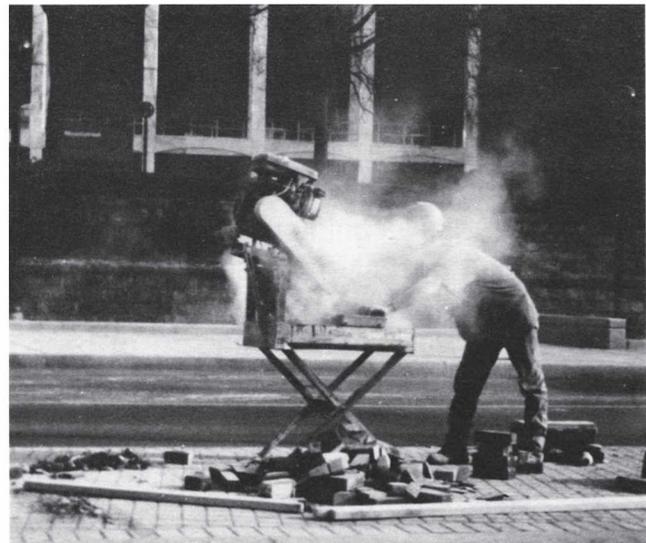
Construction worker sawing masonry without dust control or a respirator.

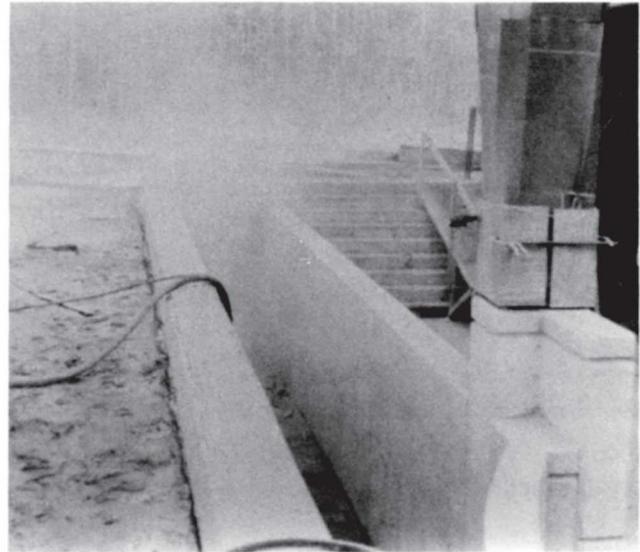
Figure 1. Abrasive blasting of concrete containing crystalline silica (silica sand is the abrasive).

At the site of a new building under construction (Figure 1), a sandblaster was employed to blast the surface of a poured concrete structure using silica sand. The sandblaster wore a supplied-air, Type CE continuous-flow respirator, but his helper used no respiratory protection. The amount of air flow through the supplied-air respirator was not determined. Other workers nearby (some only 20 to 25 feet from the sandblasting at various times) were either using disposable particulate respirators or had access to them. For the sandblaster, 60-minute personal air samples indicated a respirable quartz concentration of  $0.68 \text{ mg/m}^3$  inside and  $1.83 \text{ mg/m}^3$  outside the Type CE continuous-flow respirator. For the blaster helper, a 57-minute personal air sample indicated a respirable quartz concentration of  $0.52 \text{ mg/m}^3$ . A 65-minute area air sample indicated a respirable quartz concentration of  $0.26 \text{ mg/m}^3$ .

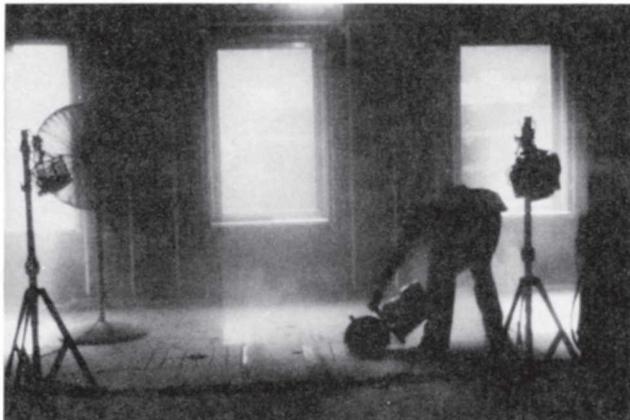
Figure 2. Plumber sawing concrete floors containing crystalline silica.

During renovation of a high-rise office building (Figure 2), a plumber cut the concrete floor on each of the 16 floors to install rest room floor drains. He wore a disposable particulate respirator and used a floor-stand fan to direct dust out the window. A 350-minute personal air sample indicated a respirable quartz concentration of  $14.2 \text{ mg/m}^3$ . Area air samples indicated 3.2, 3.36, and  $4.1 \text{ mg/m}^3$  respirable quartz. Other workers in the area (such as

elevator mechanics) were exposed without respiratory protection.

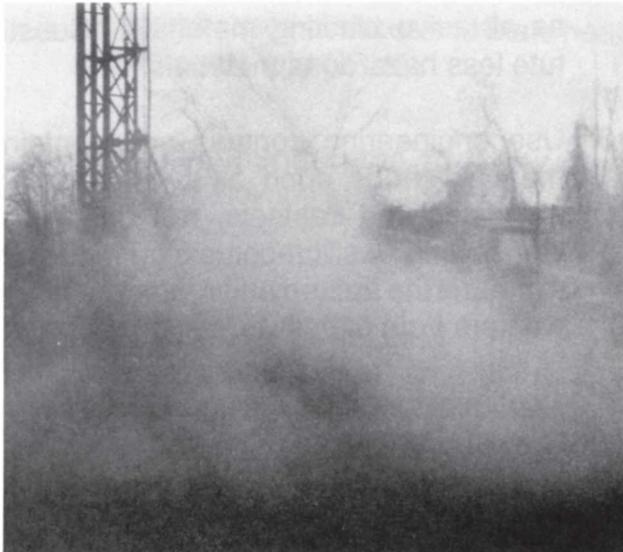
Figure 3. Drilling of rock containing crystalline silica during building site preparation.

At the site of a building under construction (Figure 3), a hillside was drilled and blasted to give access to the building site. A drill operator stood at the controls of a drill without a cab; he wore a half-face respirator with pesticide cartridges, which he had purchased himself at an auto parts store. During air sampling, the dust collection system for the drill was not operable, and water was not used as a dust suppressant. A 324-minute personal air sample indicated a respirable quartz concentration of  $0.80 \text{ mg/m}^3$ .

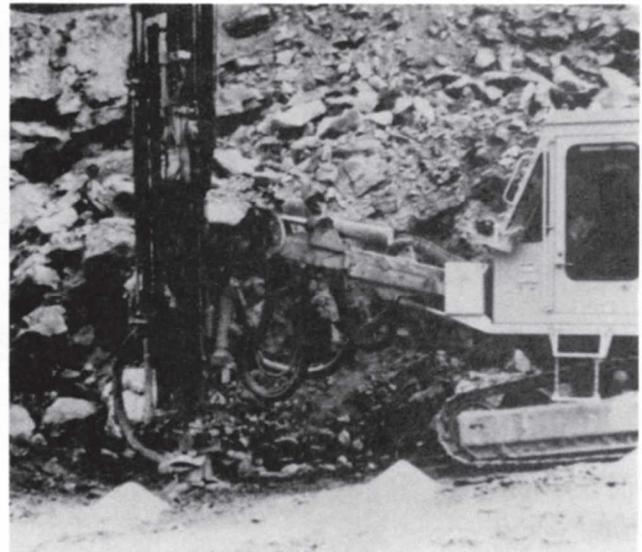
Figure 5. Drilling of rock containing crystalline silica during highway construction.

At a highway construction site, a hillside was drilled and blasted to make room for a new, wider highway (Figure 5). The drill operator was seated in an enclosed, air-conditioned drill cab. Two shifts were sampled without detecting respirable quartz in air samples from the driller's cab or from a personal sampler on the driller—even though bulk dust samples of the drill cuttings indicated 60%, 71%, 55%, and 60% quartz.

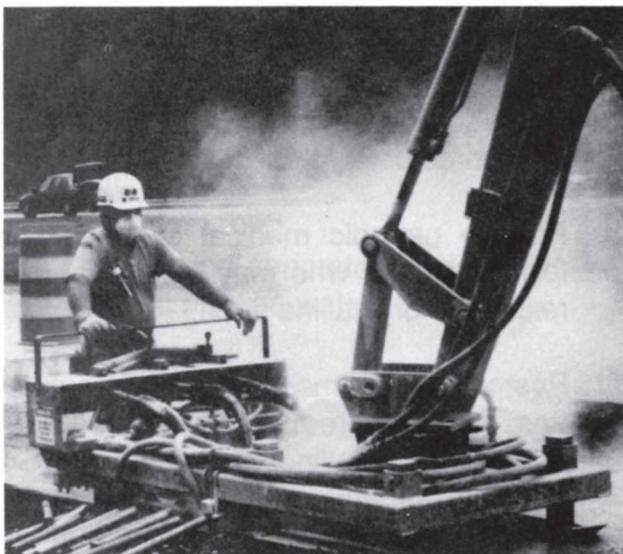
Figure 4. Drilling of concrete pavement containing crystalline silica during interstate highway repair.

During interstate highway repair, four workers drilled horizontal holes in concrete pavement after a rectangular portion of damaged concrete was removed (Figure 4). Two of the workers operated backhoes fitted with a special drill attachment, and the other two workers positioned the drill and drilled the holes. No dust collection system or water suppressant was in use. One of the backhoe operators wore a disposable particulate respirator, and the other wore a half facepiece particulate

cartridge respirator. One drill operator wore a disposable particulate respirator, and the other wore a quarter-facepiece particulate filter respirator. Personal air samples (approximately 200 minutes each) were taken on two different days. Air concentrations were above the REL for one of the backhoe operators on the first day ( $0.08 \text{ mg/m}^3$ ) and for both drill operators on both days ( $0.81$  and  $0.41 \text{ mg/m}^3$  on day 1, and  $0.42$  and  $0.32 \text{ mg/m}^3$  on day 2).

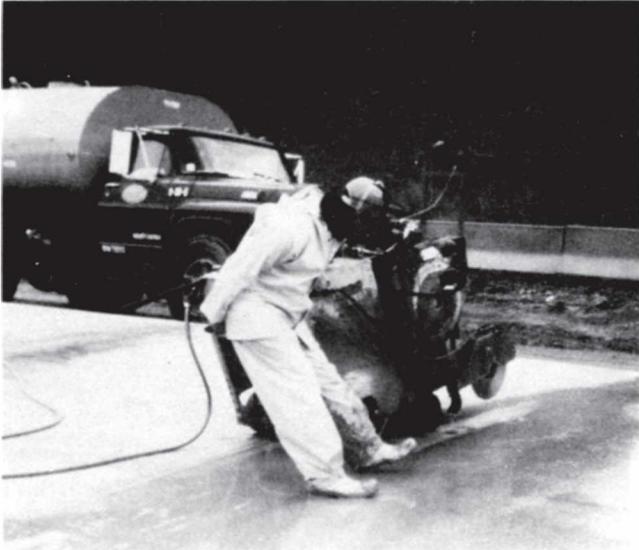
Figure 6. Sawing of concrete pavement containing crystalline silica during highway construction.

At a new highway construction site, the concrete pavement was sawed to provide expansion joints for the concrete (Figure 6). Two workers operated commercial-type pavement saws, and one operated a water truck. The water truck provided water for the blades of

the two saws (gravity feed). Personal air samples were collected for the three workers during a 4-hour shift and a 9-hour shift. Respirable quartz was not detected in any of the samples—even though bulk dust samples indicated that the concrete samples contained 18%, 19%, 21%, 22%, and 24% quartz.
